## MARINE INVESTIGATION REPORT

M00L0039

**OF THE BULK CARRIER *TECAM SEA*  
BY THE BULK CARRIER *FEDERAL FUJI***

**PORT OF SOREL, QUEBEC**

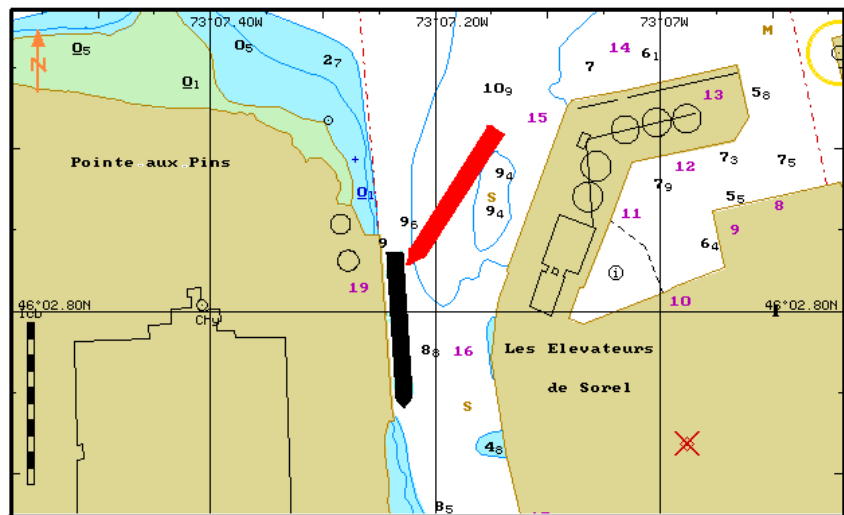
When the yaw had slowed, the pilot directed the navigation personnel to use the bow thruster to assist the tug. The vessel stopped swinging to port, then suddenly swung to starboard. At 1513, the pilot ordered dead slow ahead and hard-a-port helm, but the speed of the swing to starboard increased and the vessel moved away from berth 15. Two "kicks" ahead were ordered, including full ahead at 1516. The vessel crossed the river and approached the *Tecam Sea*, moored at berth 19.

Figure 1. Port of Sorel, approximate position of vessels

When the navigation personnel confirmed to the pilot that the bow thruster was already operating at full power and the helm was still hard-a-port, he ordered both anchors dropped. At 1517, he ordered half astern, then full astern. The port anchor was dropped, then the starboard anchor. At 1518, the starboard shoulder of the *Federal Fuji* struck the port quarter of the *Tecam Sea*. The main engine was stopped immediately, and the *Federal Fuji* moved away from the *Tecam Sea*.

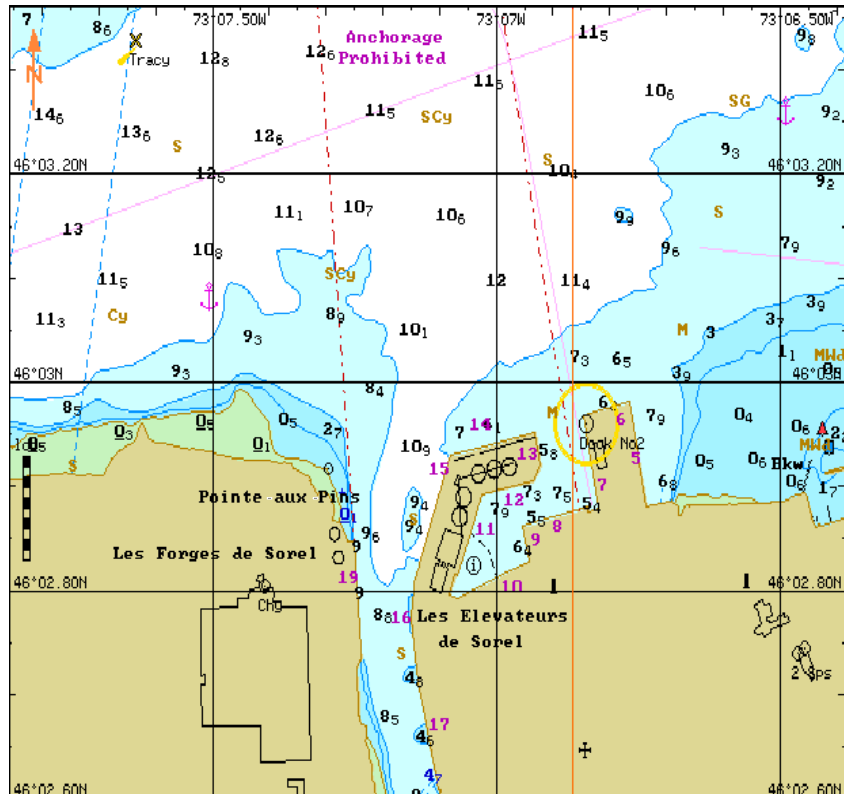
At the mouth of the Richelieu River, the current vector on the St. Lawrence River indicates a current of 1.5 knots running at 075°. A current of approximately 1 knot is indicated along the axis of the Richelieu River. The current is slightly weaker near berth 15. Flow rates in the St. Lawrence and Richelieu rivers vary with the seasons. During spring runoff, the current is stronger than the average current indicated on the chart.

Figure 2. A section of CHS electronic nautical chart C1312A

The pilot estimated that the current in the Richelieu River was 2 to 3 knots at the time of the occurrence.

The shipping channel in the Port of Sorel is dredged to a depth of 11.7 m, but the centre of the estuary is dredged less often. The chart inset on CHS Nautical Chart 1312 indicates that a shoal is located off berth 15, reducing the usable water depth to 9.4 m above chart datum. This shoal was dredged in December 1999, increasing the usable water depth to 10.1 m.
